PALM STREET WATER PLANT CONDITION ASSESSMENT

City of Huntsville

July 31, 2015

FREESE AND NICHOLS, INC.
11200 Broadway Street
Offices West, Suite 2332
Pearland, TX 77584
832-456-4700

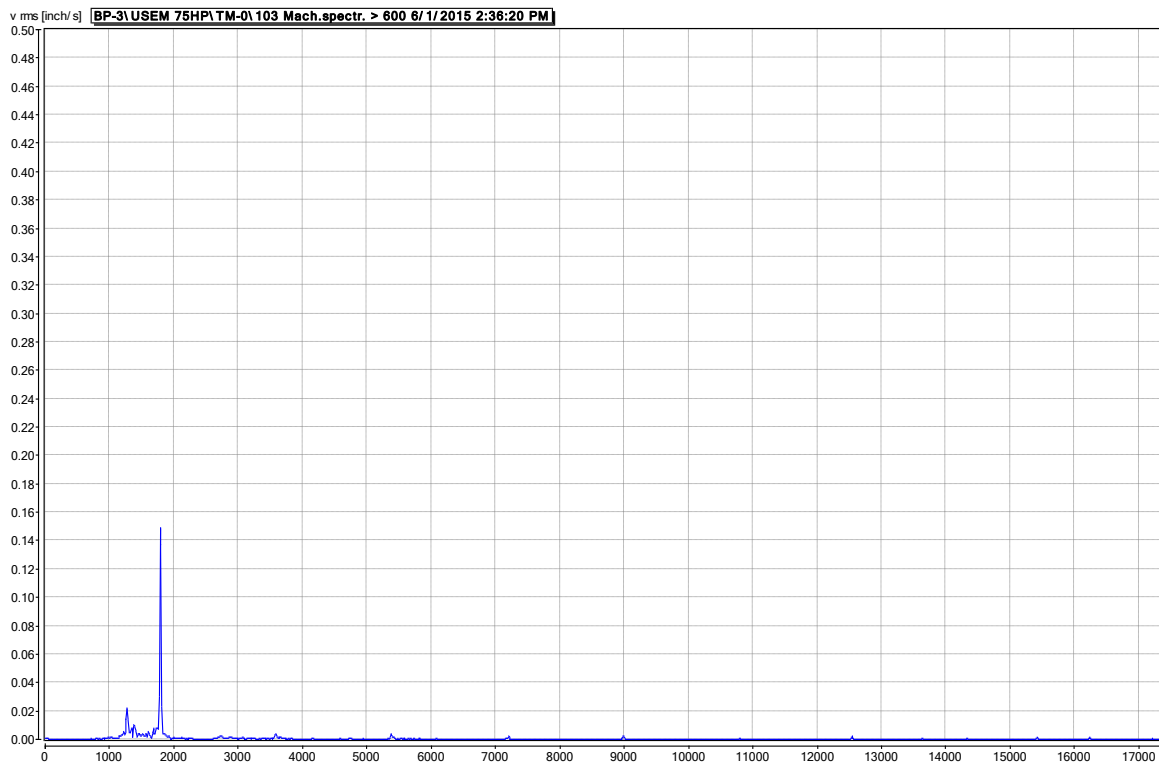
Figure 24: MT-0 Filtered Vibration, highest peak is 0.149 in/sec at 1,792 cpm (1X run speed)

The vibration at all of the locations has a dominant peak at 1X run speed. This is a typical signature of rotating equipment and indicates a slight imbalance and/or misalignment or looseness. The amplitude for the most part is low but the vibration at the top of the motor in-line with the discharge is slightly above the HI limits. Field balancing would likely resolve this issue.

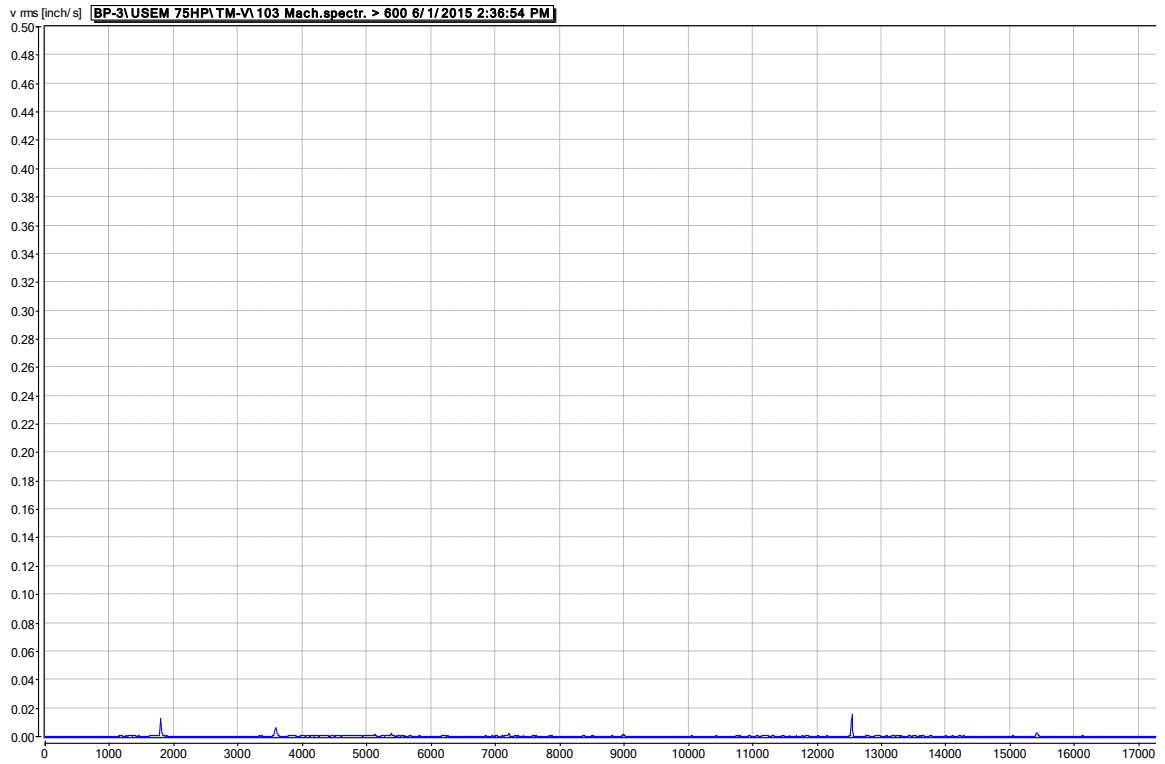
Figure 25: MT-V Filtered Vibration, all data is below 0.020 in/sec

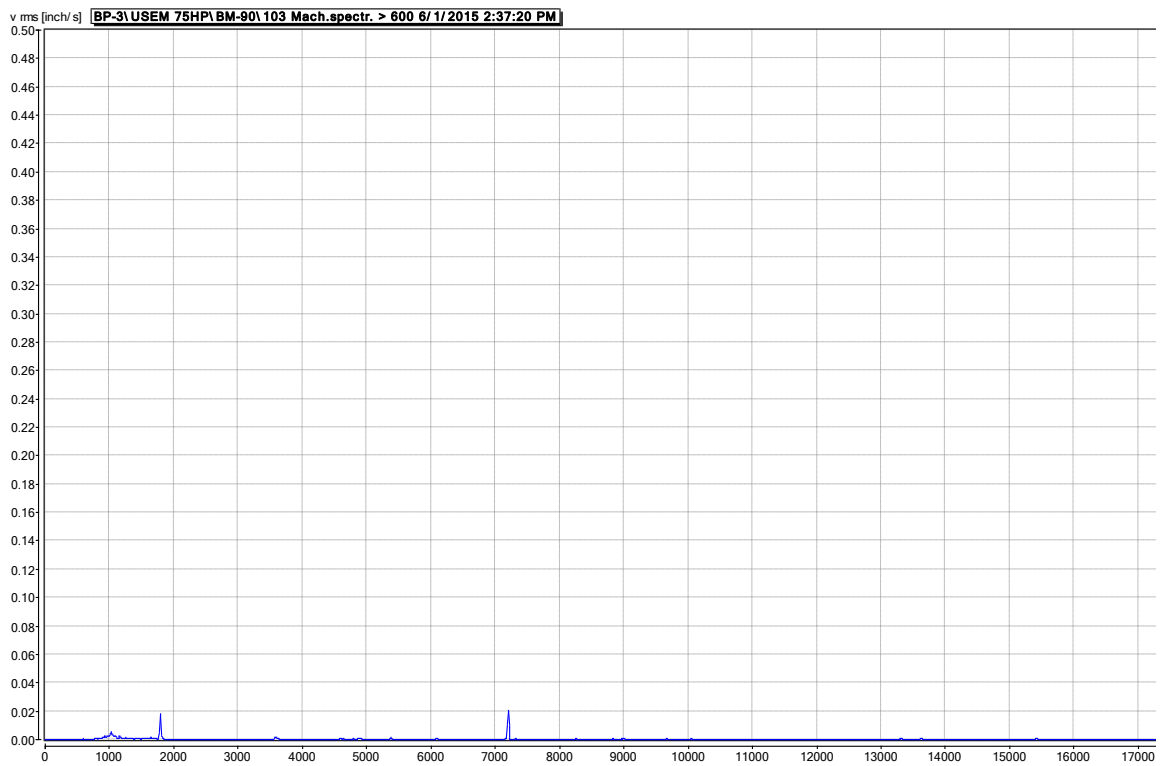
Figure 26: MB-90 Filtered Vibration, all data is below 0.020 in/sec

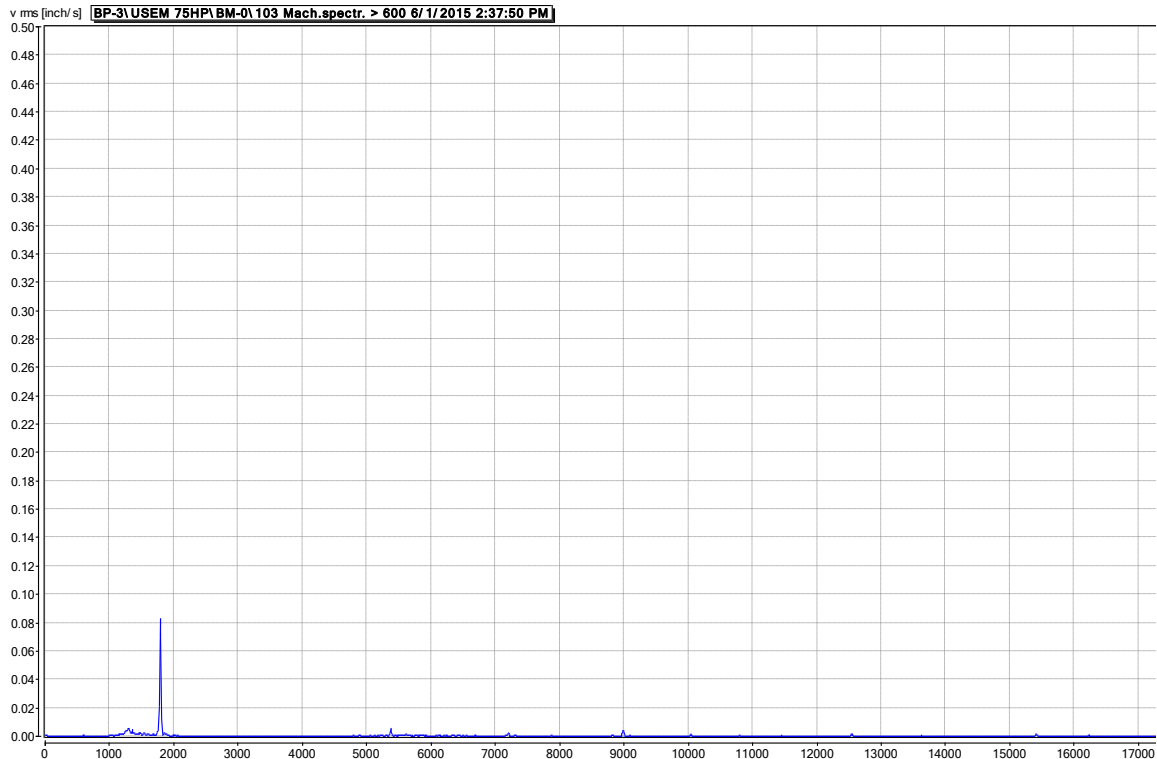
Figure 27: MB-0 Filtered Vibration, highest peak is 0.082 in/sec at 1,792 cpm (1X run speed)

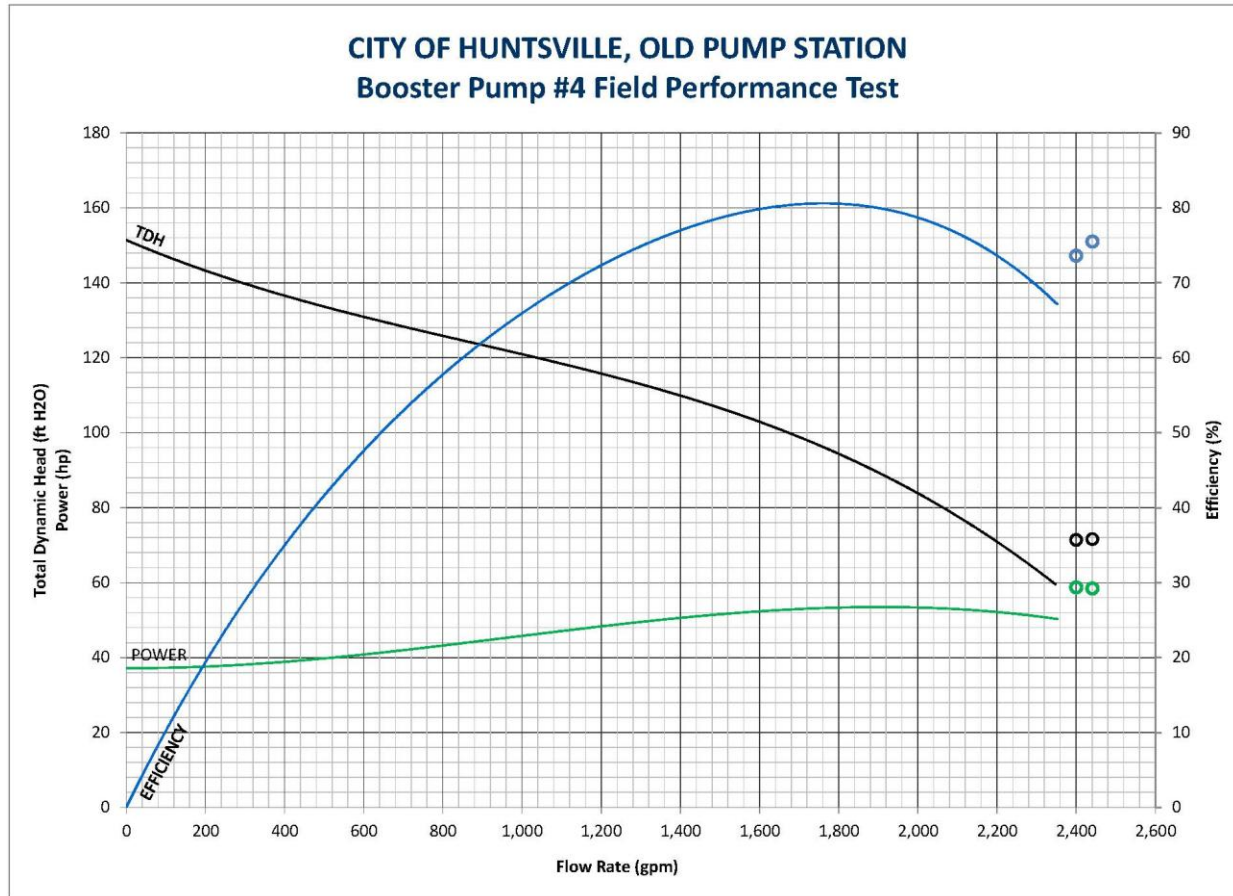
The composite curve below, Figure 28, shows the field data plotted with the curve provided by the city.

Figure 28: Old Booster Pump Station, Booster Pump #4 Field Performance Curve

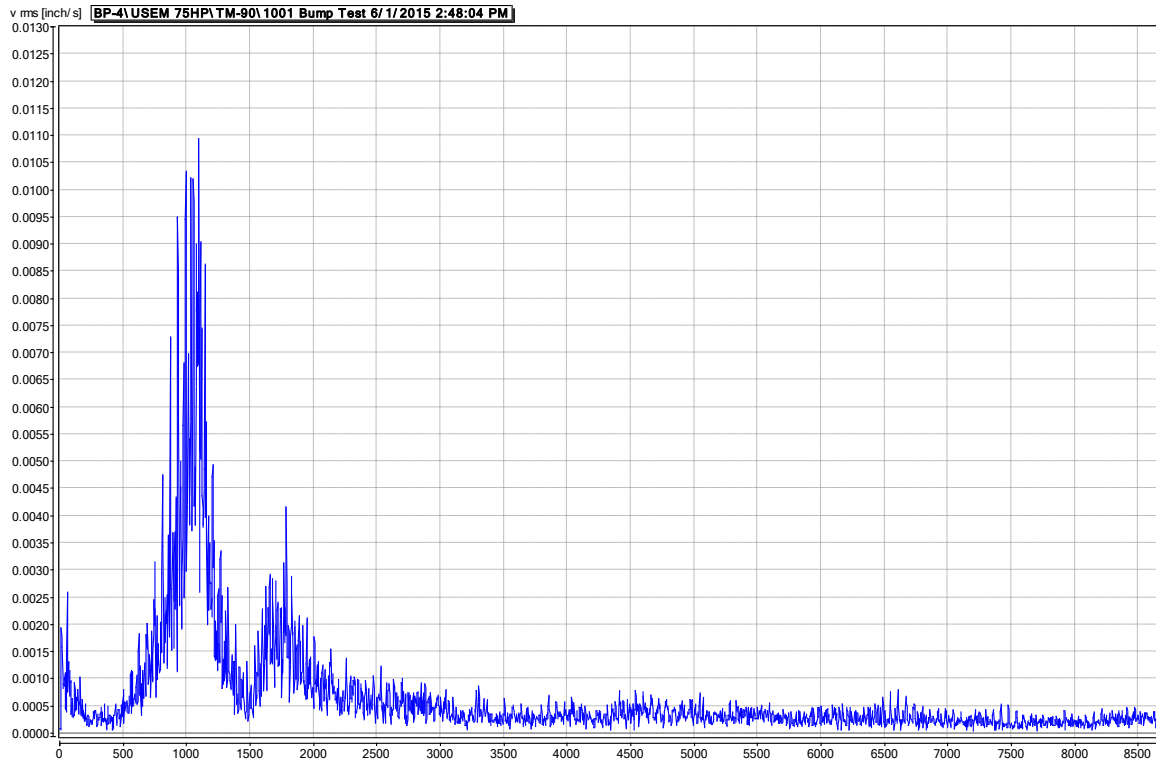
Figure 29: MT-90 Bump Test, Reed Frequency at 1,095 cpm, Motor Speed is 1,785 rpm

The reed frequency, as shown in Figures 29, is at 1,095 cpm 90 degrees to discharge which is 39% from run speed and should not cause any issues. The reed frequency, as shown in Figure 30, is at 1,243 cpm which is 30% from run speed and should not cause any issues.

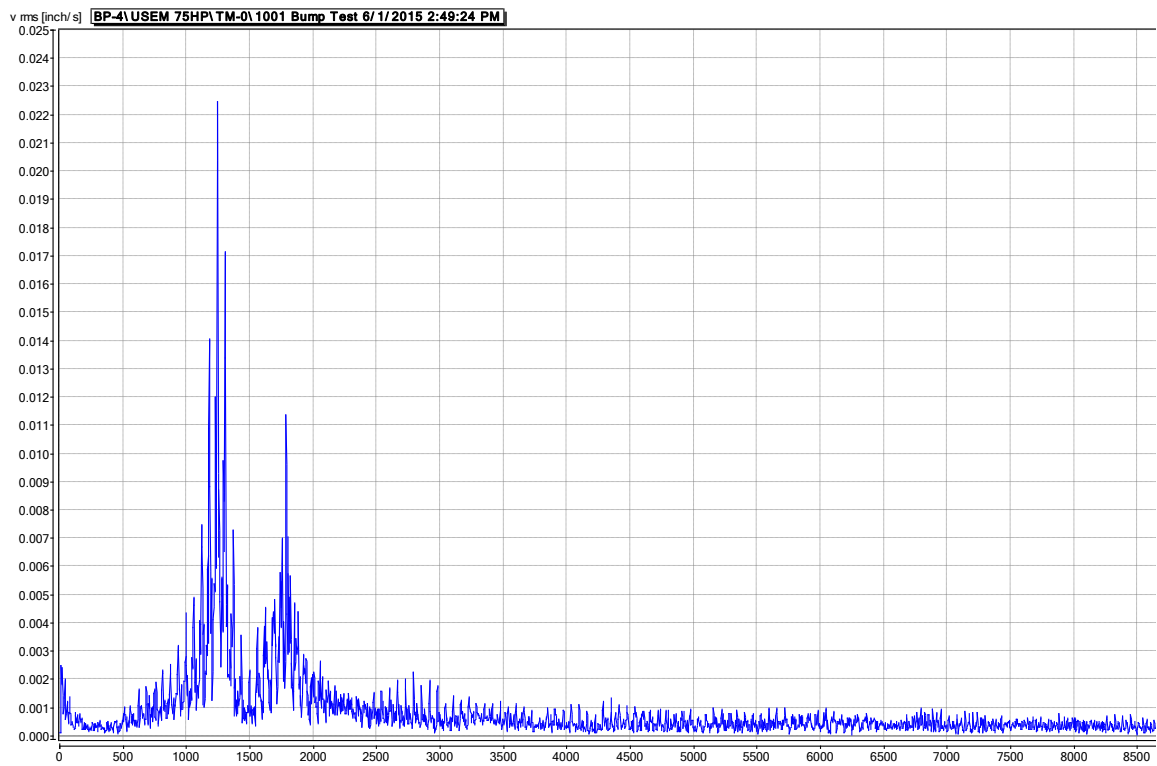
Figure 30: MT-0 Bump Test, Reed Frequency at 1,243 cpm, Motor Speed is 1,785 rpm

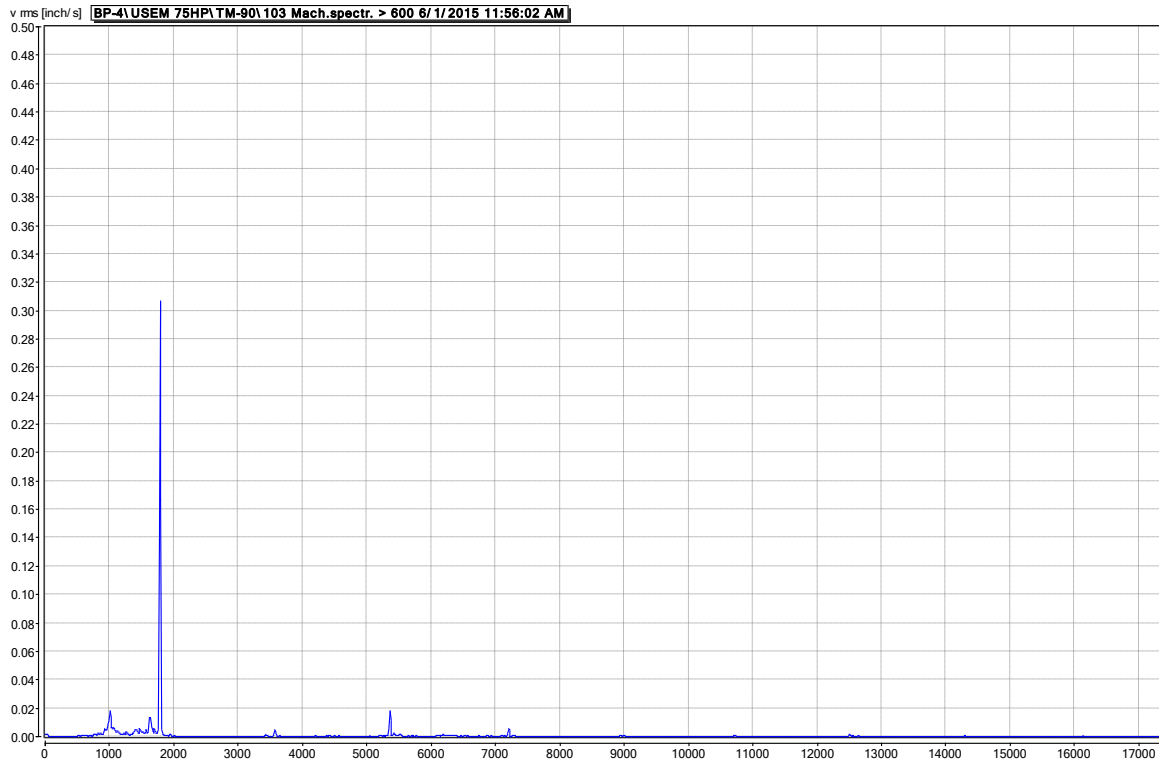
Figure 31: MT-90 Filtered Vibration, highest peak is 0.307 in/sec rms at 1,785 cpm (1X run speed)

The vibration at all of the locations has a dominant peak at 1X run speed. This is a typical signature of rotating equipment and indicates a slight imbalance and/or misalignment or looseness. The amplitude is very high at the locations that are in-line and 90 degree to the discharge and should be corrected. Field balancing may resolve the issue but it is more likely caused by loose pump bearings which would require the pump to be pulled and repaired

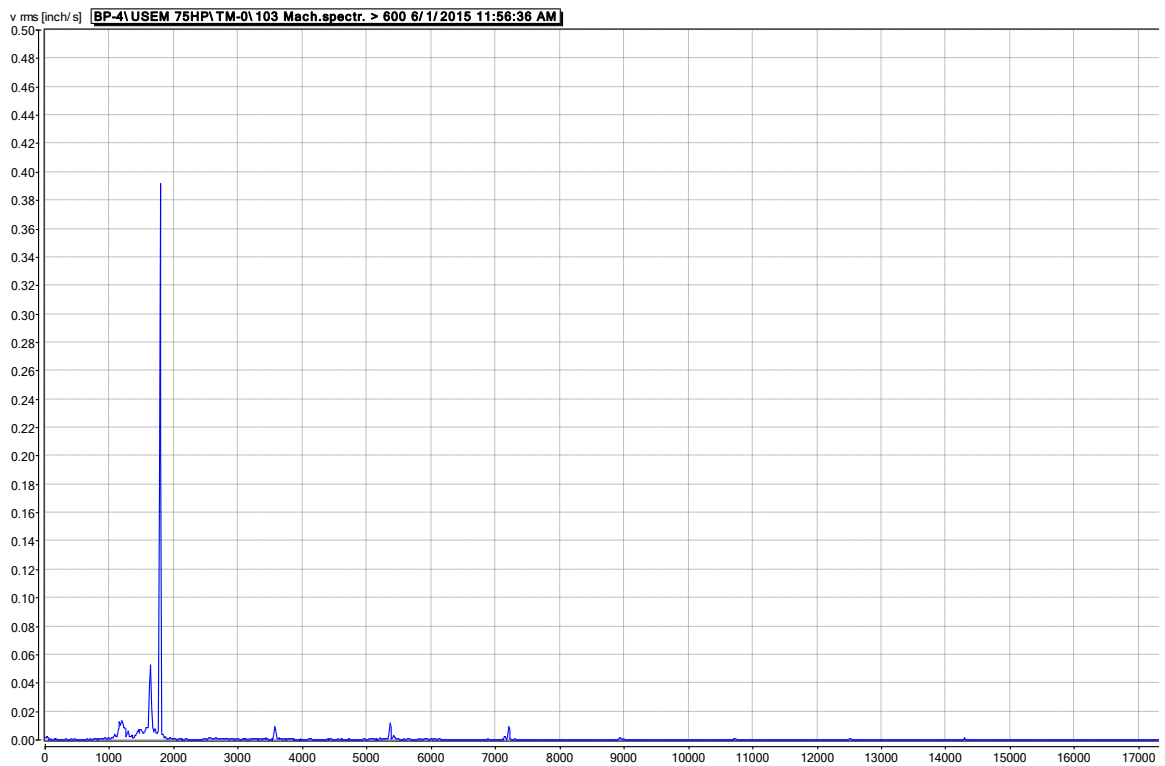
Figure 32: MT-0 Filtered Vibration, highest peak is 0.392 in/sec at 1,785 cpm (1X run speed)

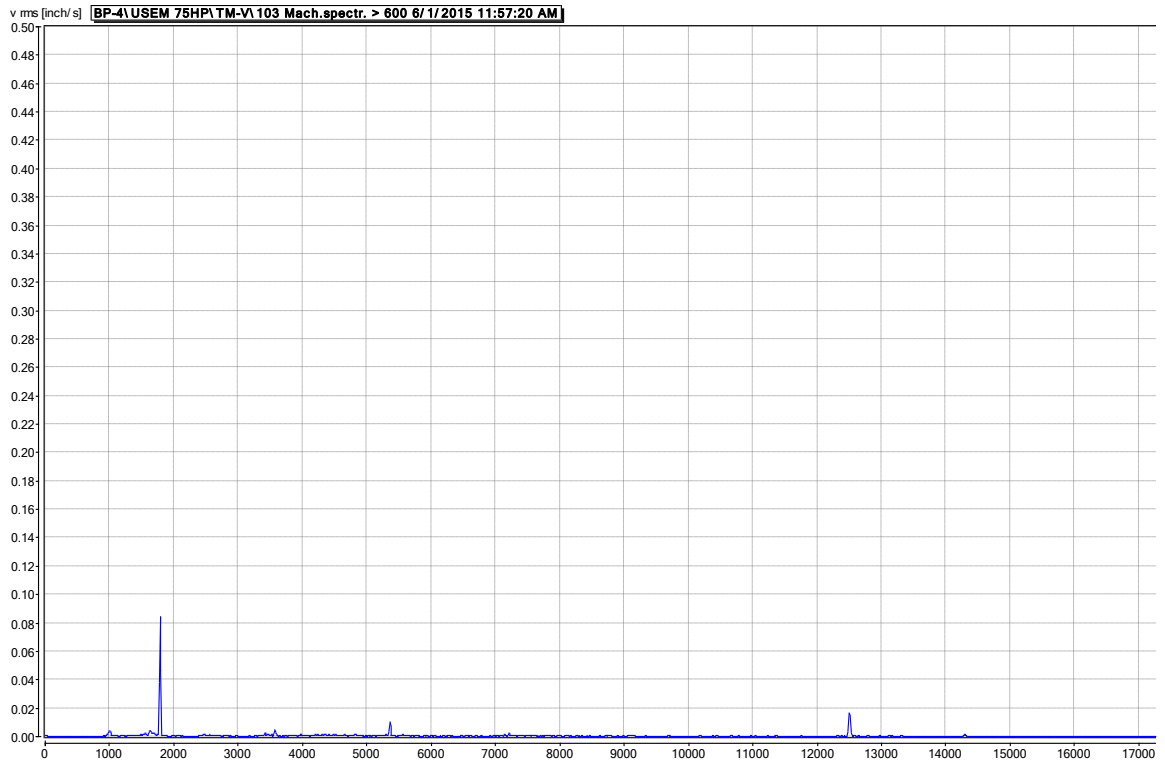
Figure 33: MT-V Filtered Vibration, highest peak is 0.084 in/sec at 1,785 cpm (1X run speed)

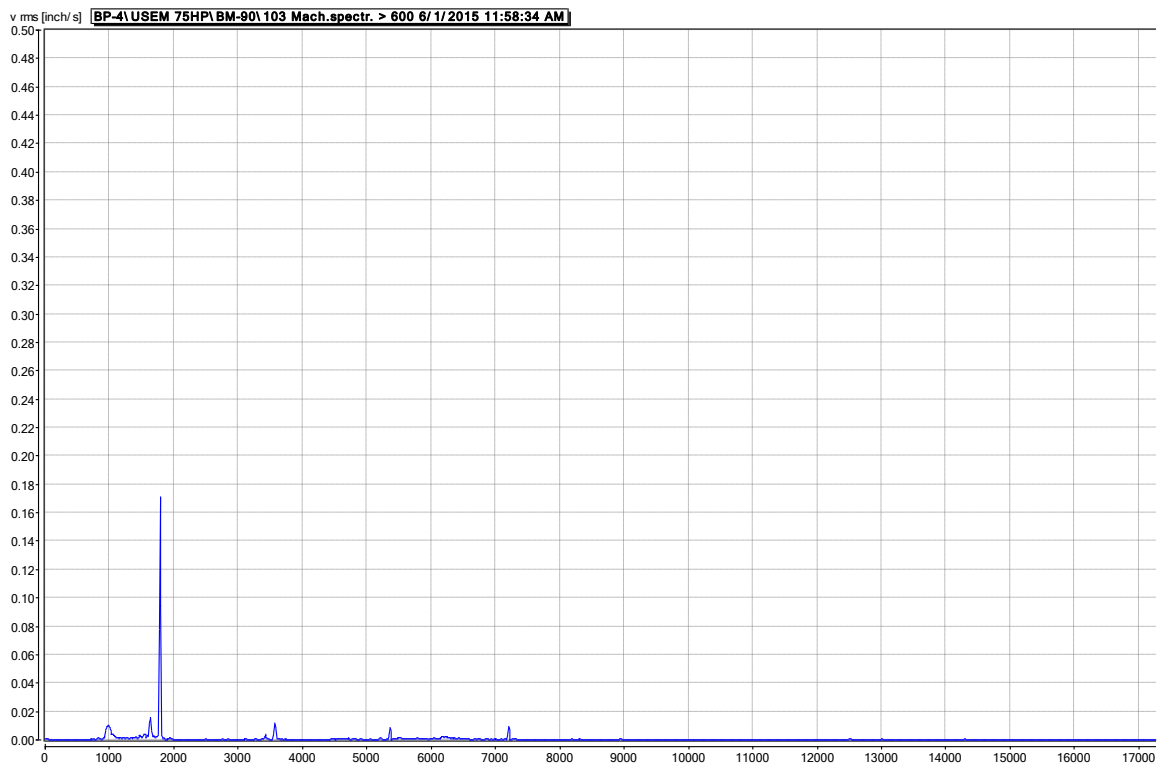
Figure 34: MB-90 Filtered Vibration, highest peak is 0.171 in/sec at 1,785 cpm (1X run speed)

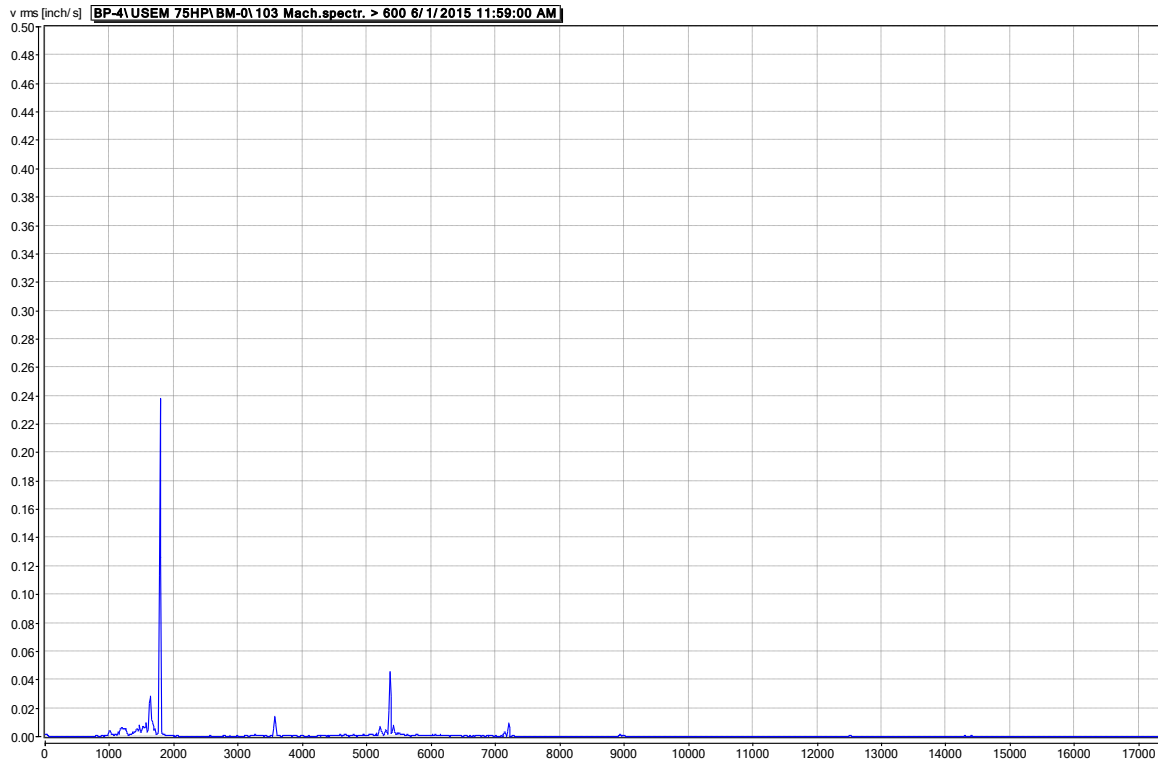
Figure 35: MB-0 Filtered Vibration, highest peak is 0.238 in/sec at 1,785 cpm (1X run speed) and the second highest peak is 0.046 in/sec at 5,358 cpm

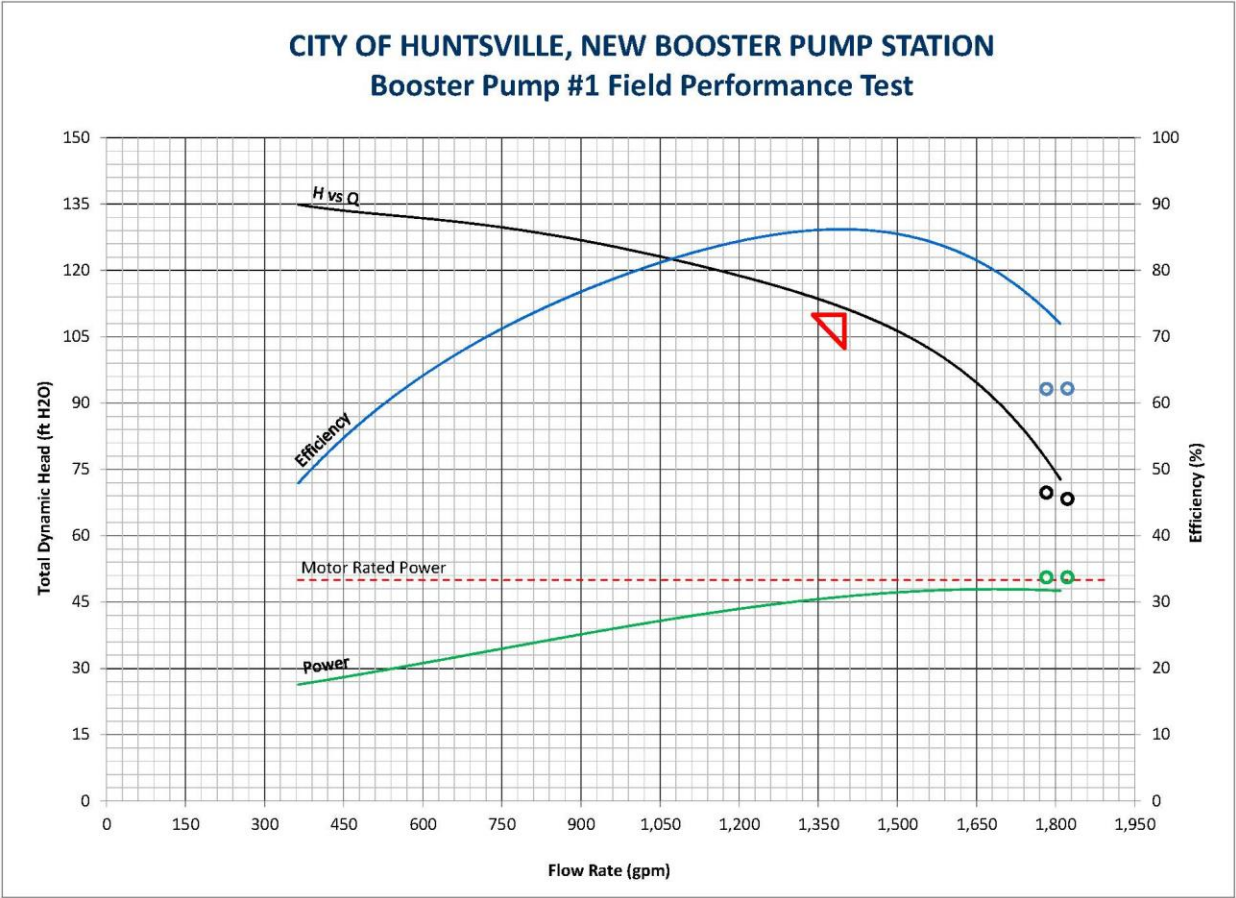
The pump performance test data (hydraulic) shows the two (2) field test points recorded for each pump, shown with circles, and the catalog curve. The instrument values are recorded in concert with one another. The data is reduced to result in the points that show up in the composite curve chart in Figure 36 below. The data is speed corrected to the catalog curve test speed so that the test data can be compared.

Figure 36: New Booster PS, Booster Pump #1 Field Performance Curve

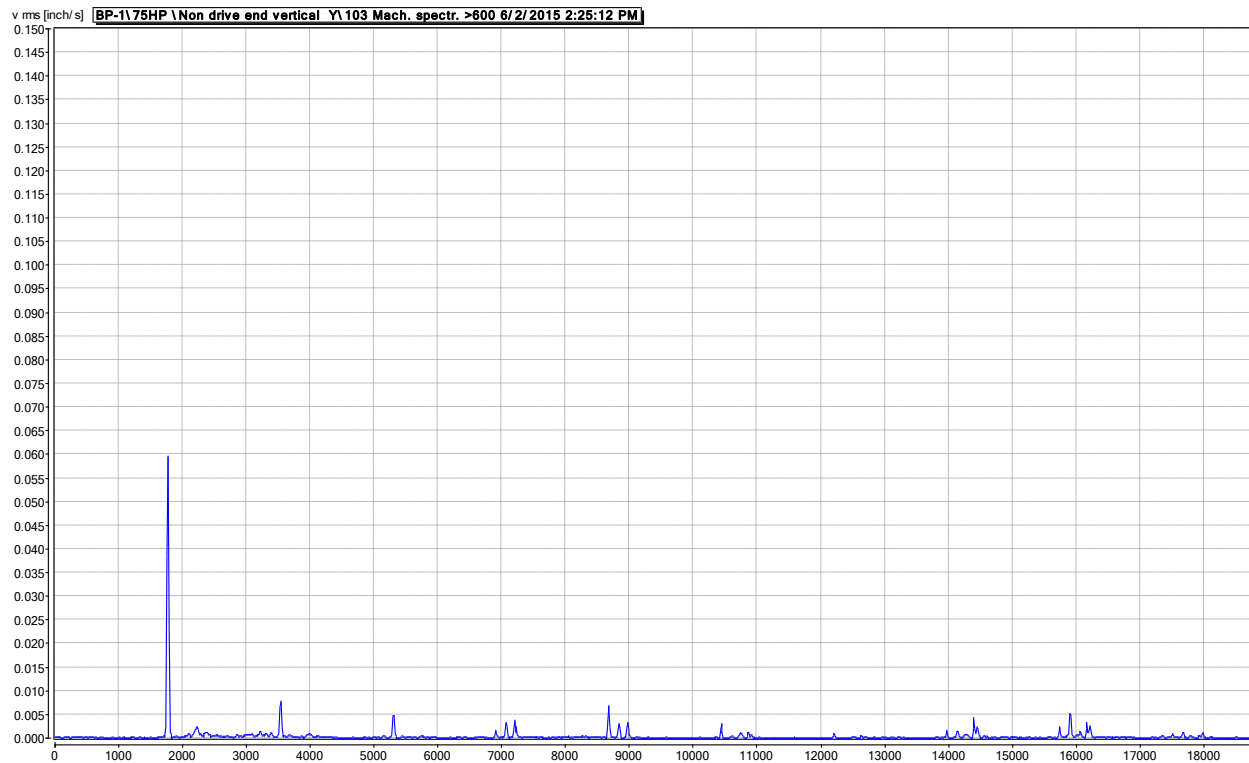
Figure 37: Motor ODE-Y Filtered Vibration, highest peak is 0.060 in/sec at 1,766 cpm (1X run speed)

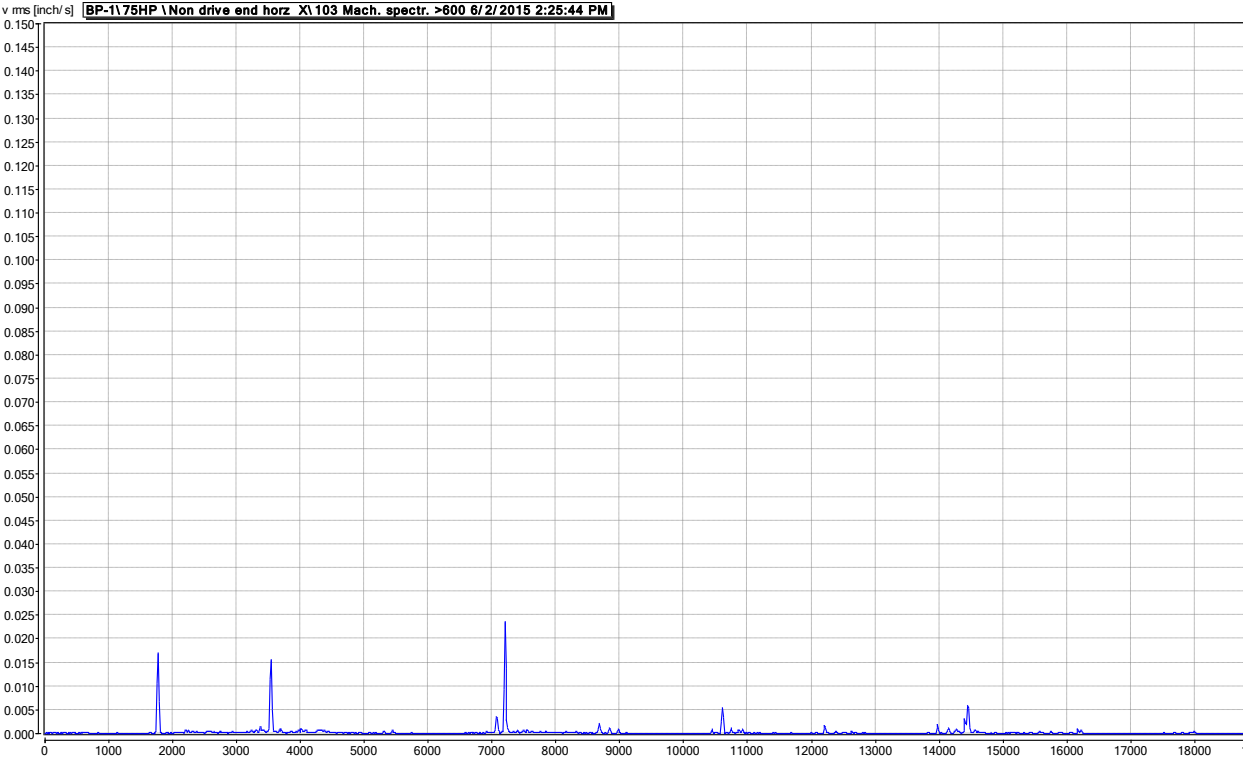
Figure 38: Motor ODE-X Filtered Vibration, highest peak is 0.024 in/sec at 7,200 cpm (1X run speed) with other peaks at 1,766 cpm (1X run speed) and 3,536 cpm (2X run speed)

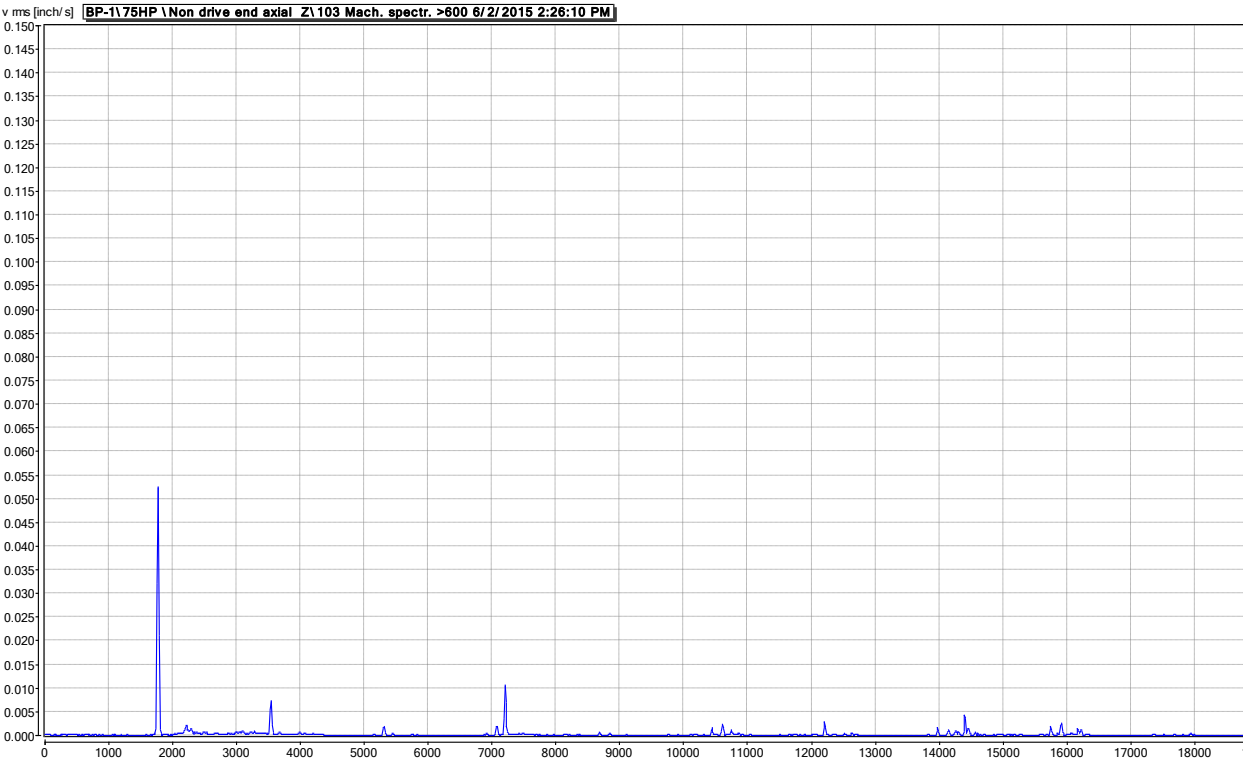
Figure 39: Motor ODE-Z Filtered Vibration, highest peak is 0.053 in/sec at 1,785 cpm (1X run speed)

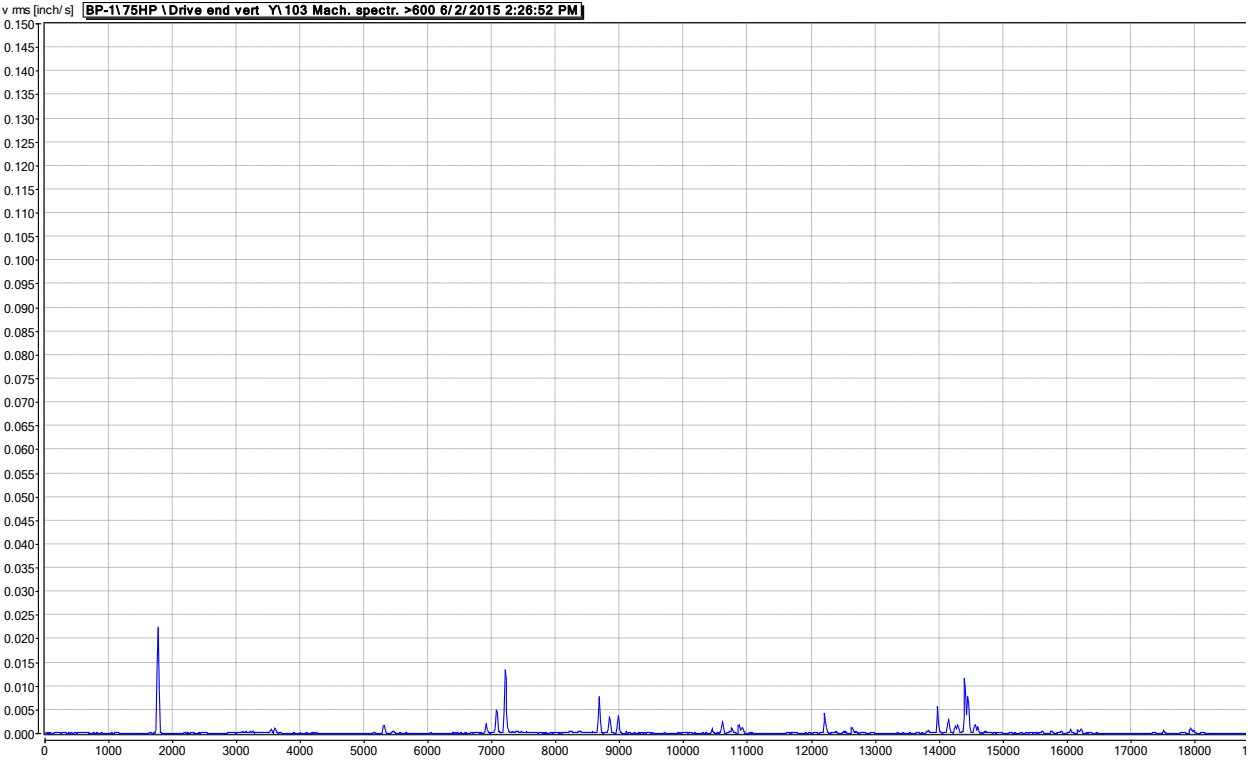
Figure 40: Motor DE-Y Filtered Vibration, highest peak is 0.022 in/sec at 1,766 cpm (1X run speed) with a smaller peak at 7,200 cpm (electrical frequency)

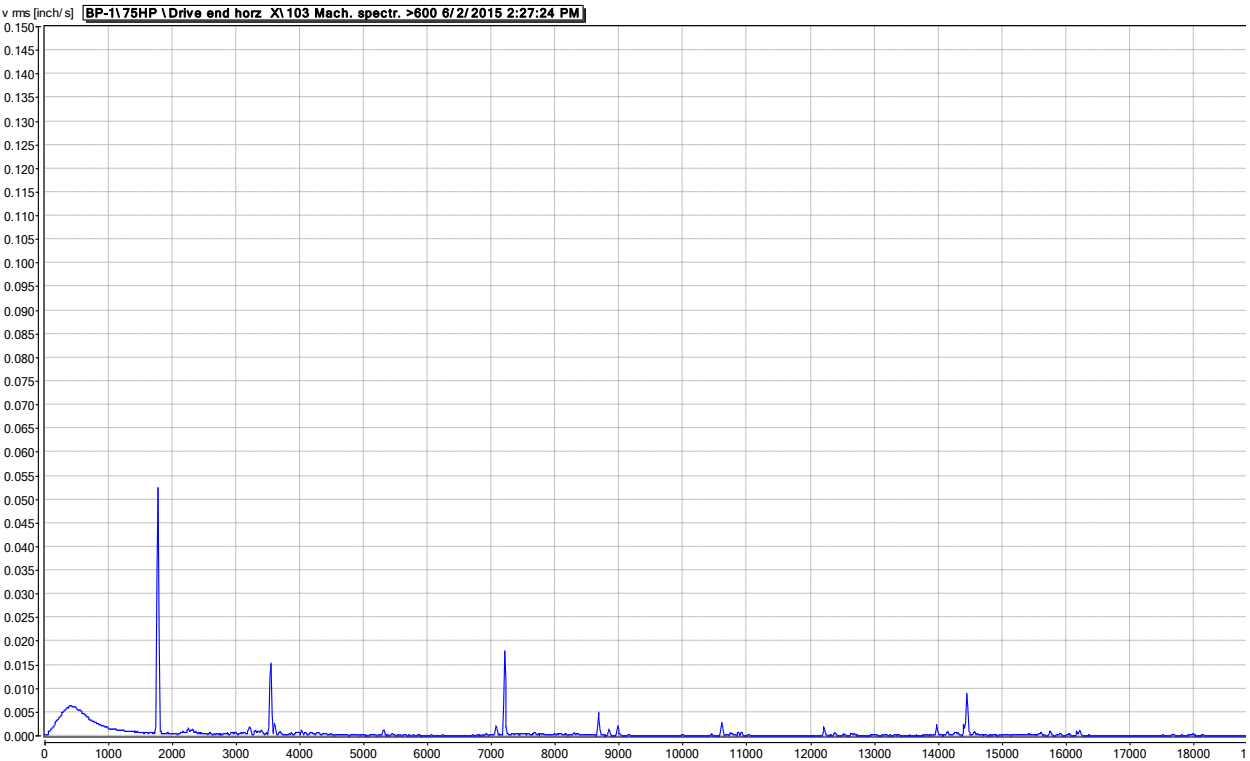
Figure 41: Motor DE-X Filtered Vibration, highest peak is 0.053 in/sec at 1,766 cpm (1X run speed) with a smaller peak at 3,536 cpm (2X run speed) and 7,200 cpm (electrical frequency)

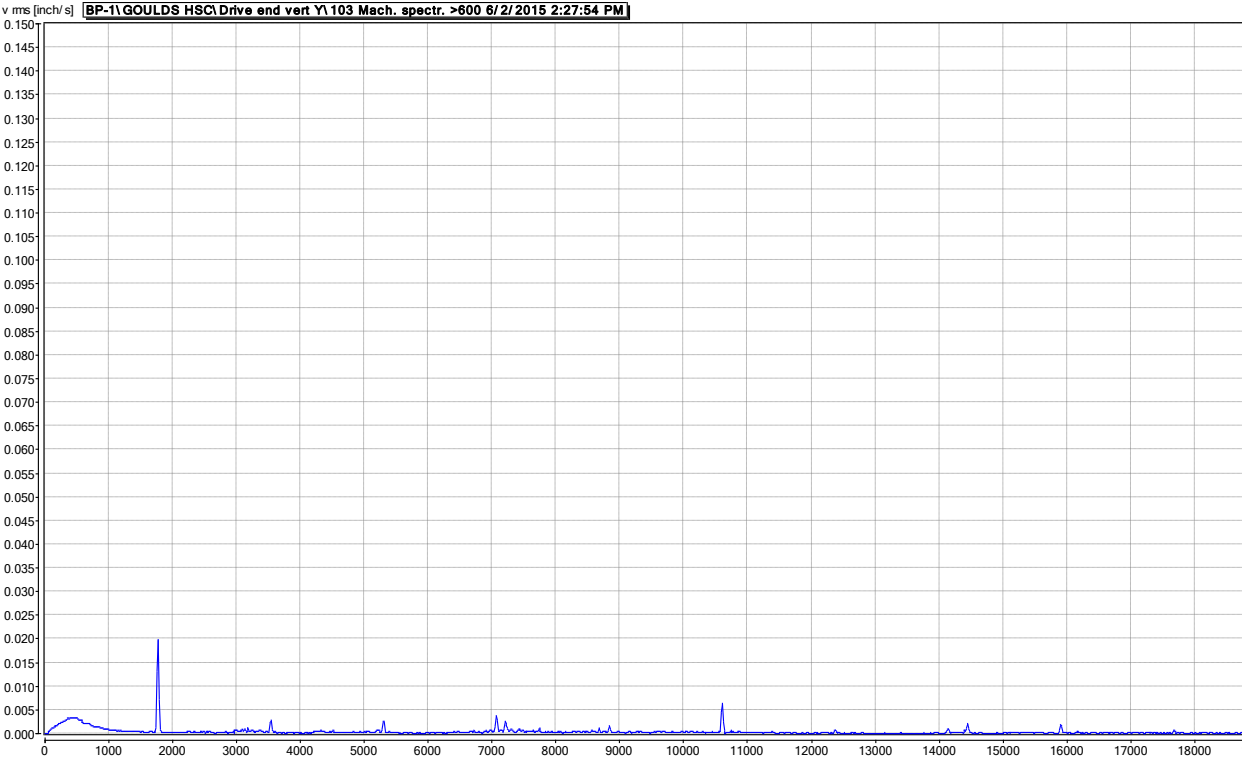
Figure 42: Pump DE-Y Filtered Vibration, highest peak is 0.020 in/sec at 1,766 cpm (1X run speed)

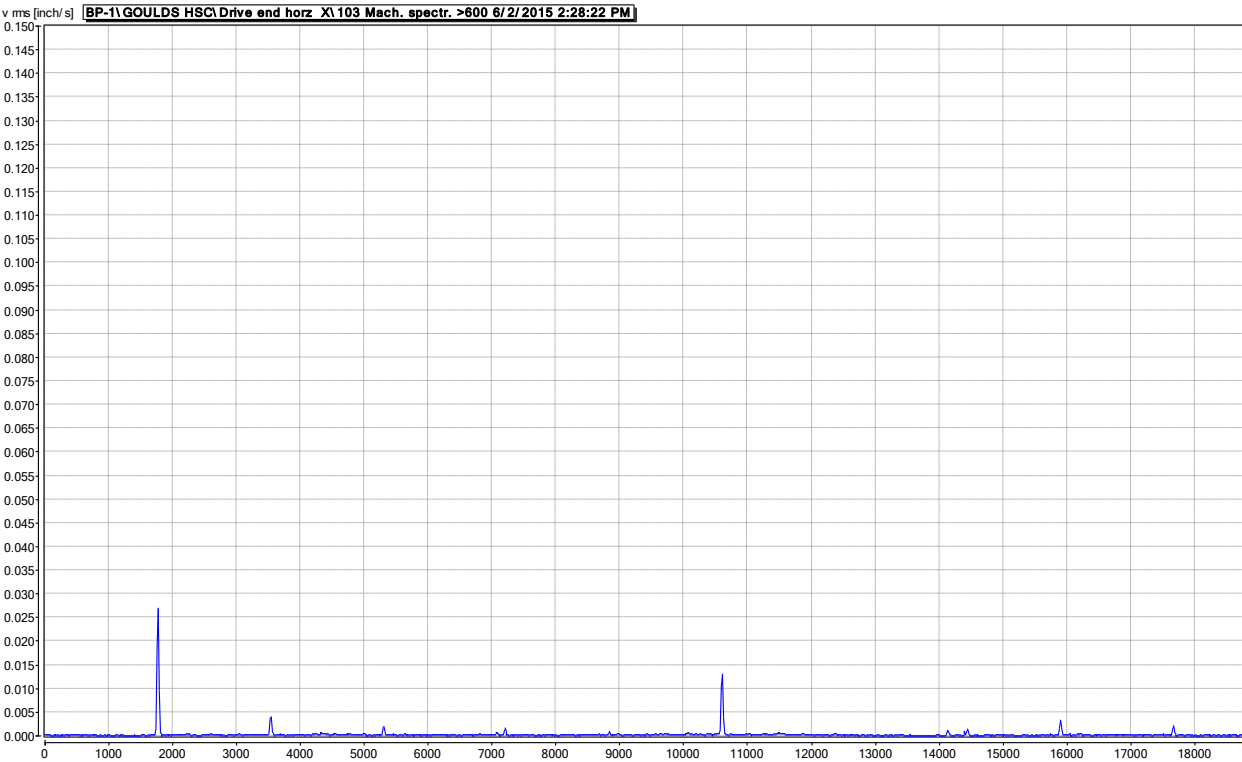
Figure 43: Pump DE-X Filtered Vibration, highest peak is 0.027 in/sec at 1,766 cpm (1X run speed) with a smaller peak at 10,601 cpm (6X run speed)

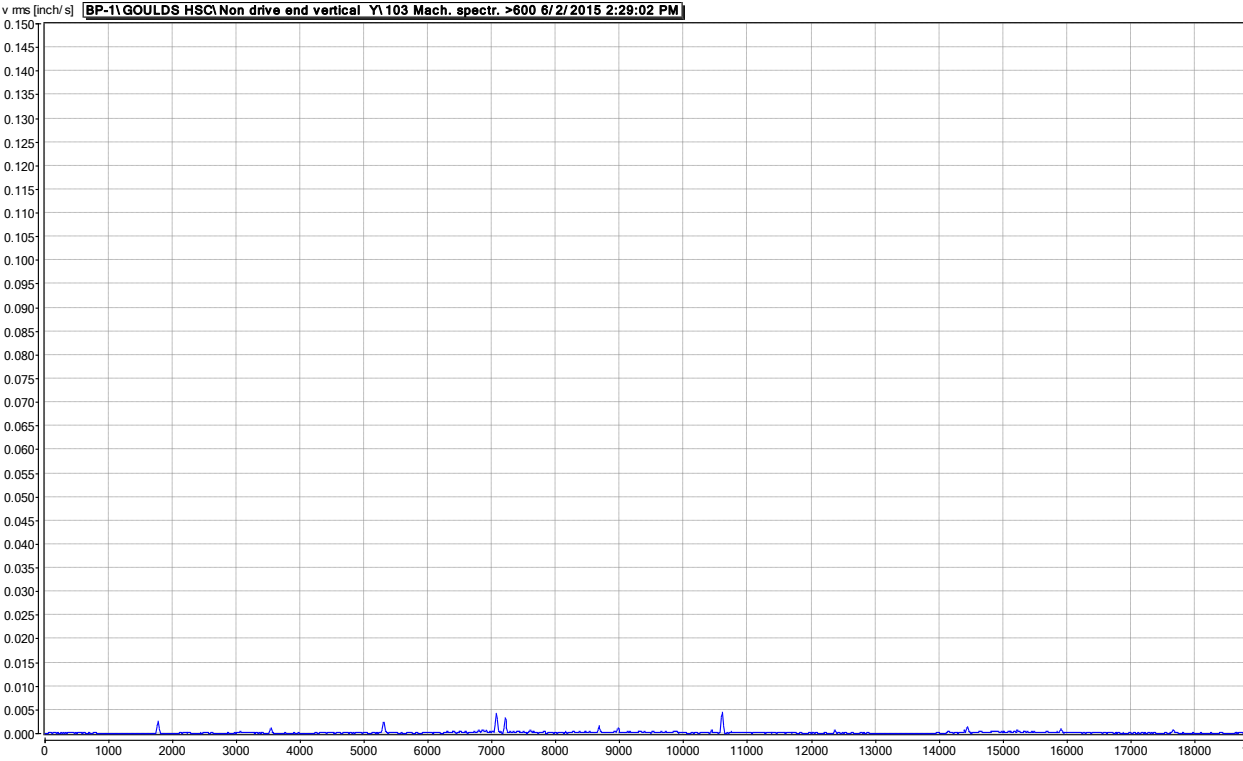
Figure 44: Pump ODE-Y Filtered Vibration, all peaks are below 0.005 in/sec

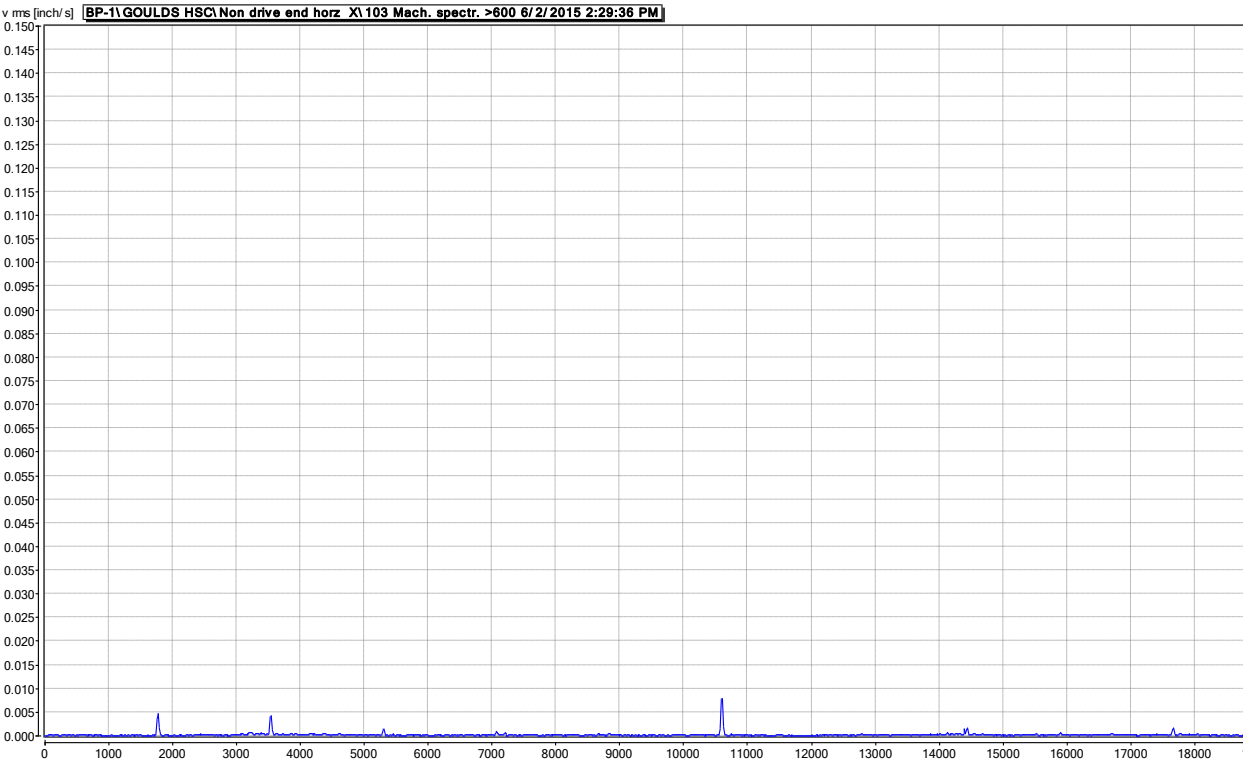
Figure 45: Pump ODE-X Filtered Vibration, all peaks are below 0.010 in/sec

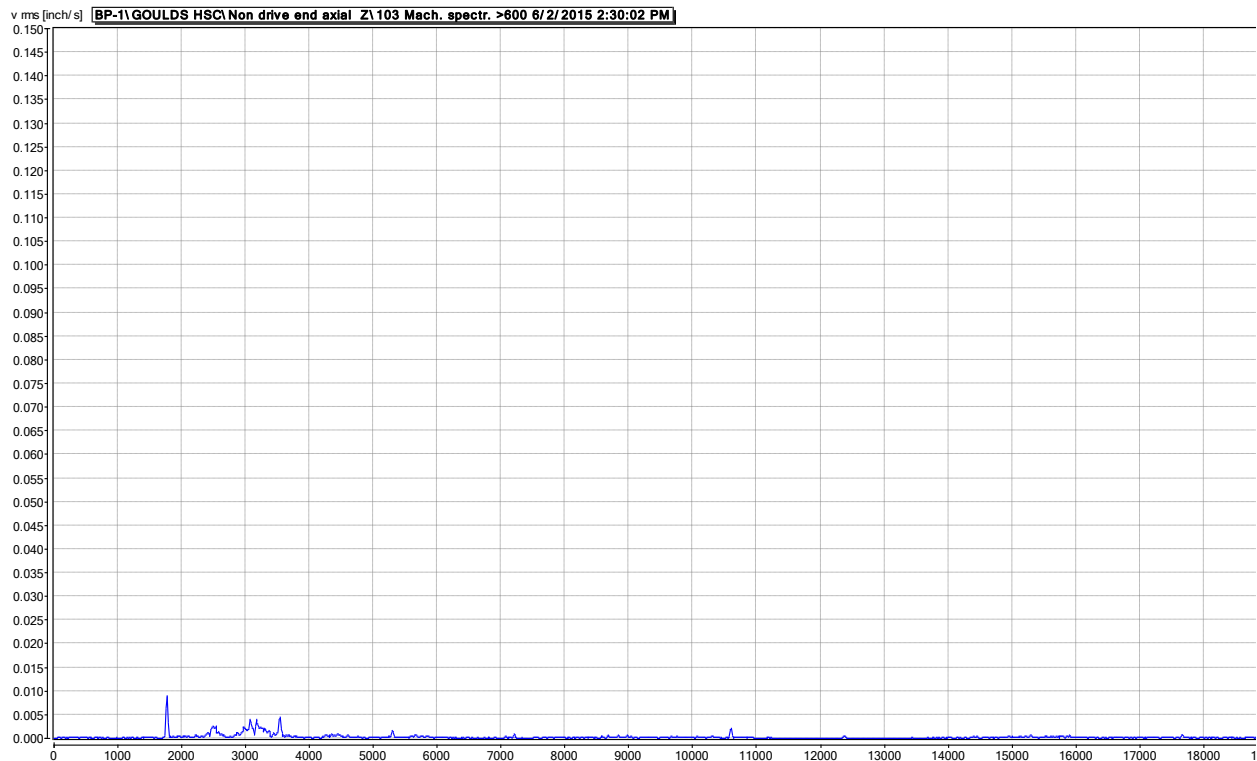
Figure 46: Pump ODE-Z Filtered Vibration, all peaks are below 0.010 in/sec

The motor and pump vibration are very low at all locations.
